PARTIAL
STURAA TEST
10 YEAR
350,000 MILE BUS
from
SUPREME CORPORATION
MODEL 34' HD CHEVY
DECEMBER 2005
PTI-BT-R0513

EXECUTIVE SUMMARY

The Supreme Corporation submitted a model 34' HD Chevy, diesel-powered 33 seat (including the driver) 32-foot bus, for a 10 yr/350,000 mile STURAA test. The odometer reading at the time of delivery was 7,989 miles. Testing started on August 8, 2005 and was completed on November 21, 2005. The Check-In section of the report provides a description of the bus and specifies its major components.

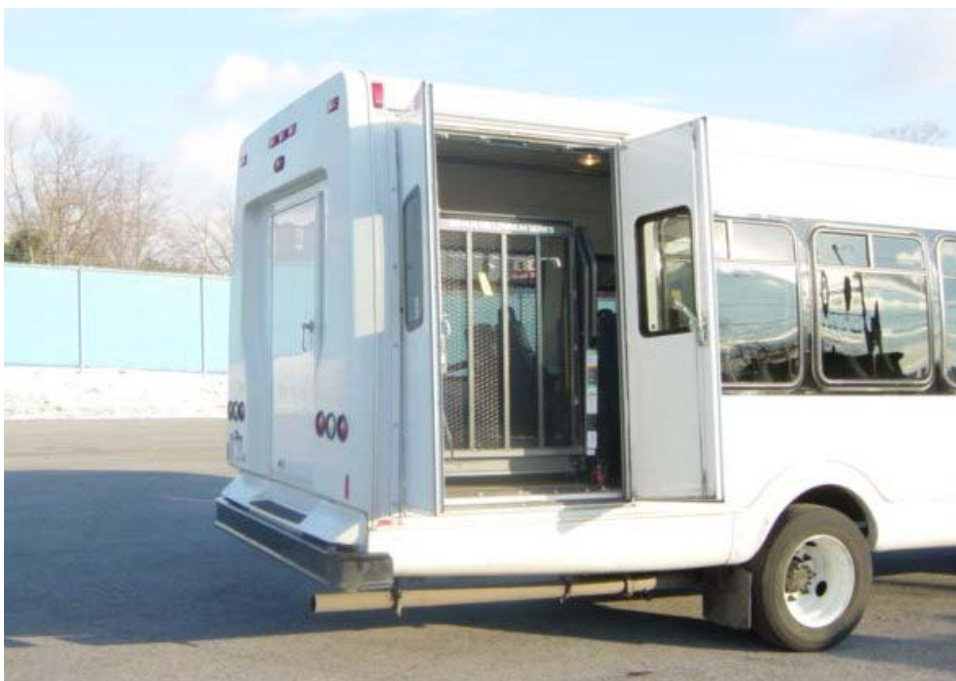
The test bus consists of a Supreme Corporation, model 34' HD Chevy. The bus is built on a Chevy 5500 chassis. The bus has a Chevy OEM driver's door and passenger entrance door rear of the front axle and a dedicated handicap entrance located rear of the rear axle which is equipped with a Braun Corp. model L917F1B handicap lift. Power is provided by a diesel-fueled, Duramax Diesel model 6.6 V8 engine coupled to an Allison model 2200 Series transmission.

**SUPREME CORPORATION'S
MODEL 34" HD CHEVY EQUIPPED WITH A BRAUN MODEL
L917F1B HANDICAP LIFT**

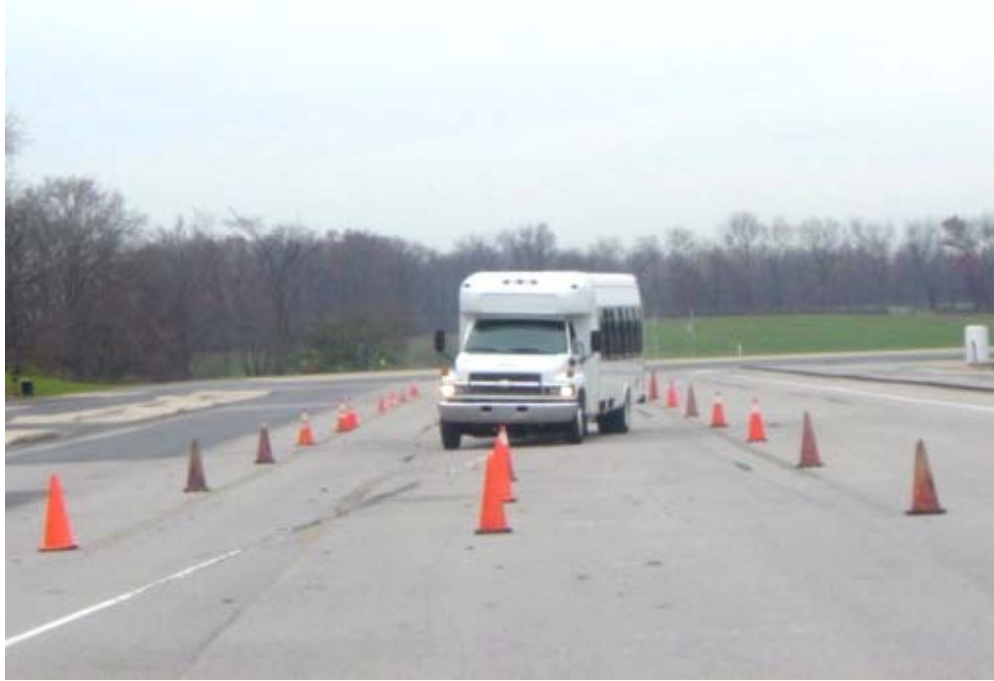
The double-lane change was performed in both right-hand and left-hand directions. The bus was able to safely negotiate the test course in both the right-hand and left-hand directions up to the maximum test speed of 45 mph.

RIGHT - HAND APPROACH

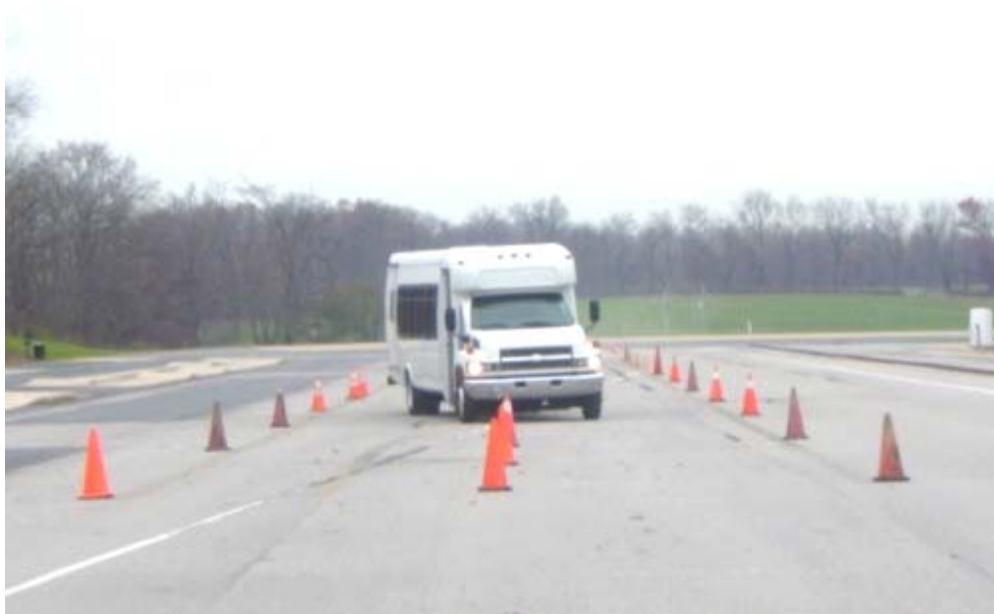
LEFT - HAND APPROACH

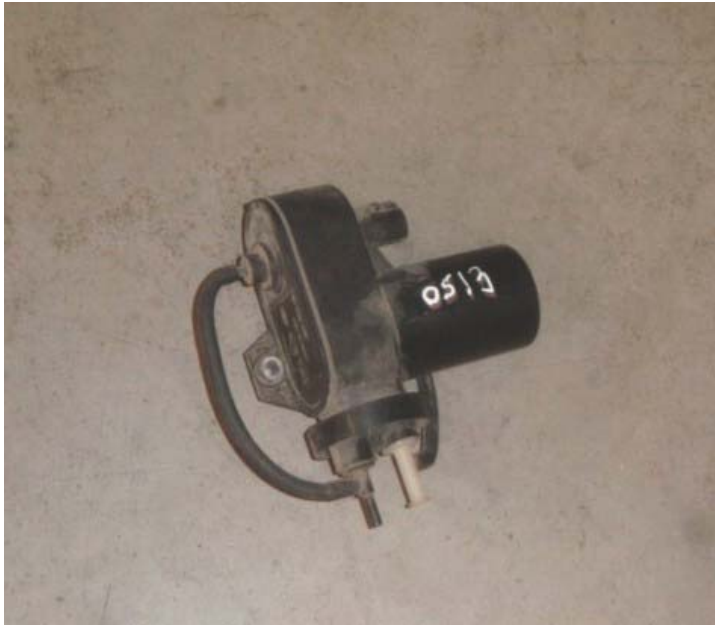
DATE	TEST MILES	SERVICE	ACTIVITY	DOWN TIME	HOURS
08-15-05	434	The tail pipe is loose.	Replaced broken hanger.	3.00	1.00
08-17-05	697	The flange is broken on the drop pie from the engine to the muffler.	Broken flange on drop pipe welded/repared.	8.00	1.50
08-19-05	1,220	The vacuum pump is inoperative.	Replaced vacuum pump.	2.00	1.00
08-22-05	1,319	Three bolts are missing from the left rear spring isolator on the frame side.	Aligned isolator and installed new bolts and nuts.	8.00	0.50
08-24-05	1,604	The left front shock is leaking oil at the bottom stud.	Left front shock replaced.	8.00	0.50
08-25-05	1,648	The flange is broken on the pipe to the exhaust manifold.	Replaced pipe. Note: the new design pipe has a brace added that is anchored to the right side bell housing.	8.00	1.00
09-02-05	2,645	The engine accessory belt is torn.	Replaced engine accessory belt.	72.00	0.50
09-19-05	2,688	Transmission will not shift properly.	Warranty dealer replaced failed speed sensor harness.	168.00	4.00

**FAILED VACUUM PUMP
(1,220 TEST MILES)**

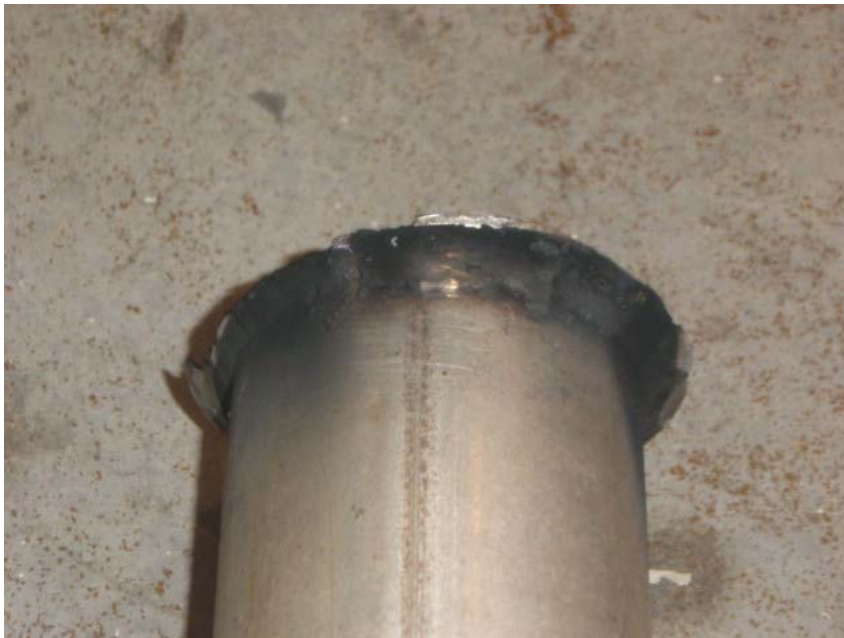
**BROKEN FLANGE ON PIPE TO EXHAUST MANIFOLD
(1,648 TEST MILES)**

09-20-05	2,688	The flange is broken on the pipe to the exhaust manifold.	Flange welded/repared.	6.00	1.00
09-21-05	2,872	The right front shock is leaking oil at the lower stud.	Right front shock replaced.	8.00	2.00
09-28-05	3,752	The lower spring leaf is broken on the right rear spring.	Right rear spring assembly replaced.	56.00	2.50
09-28-05	3,752	The tailpipe hanger bracket is broken at the weld on the frame.	Replaced hanger.	1.00	0.50

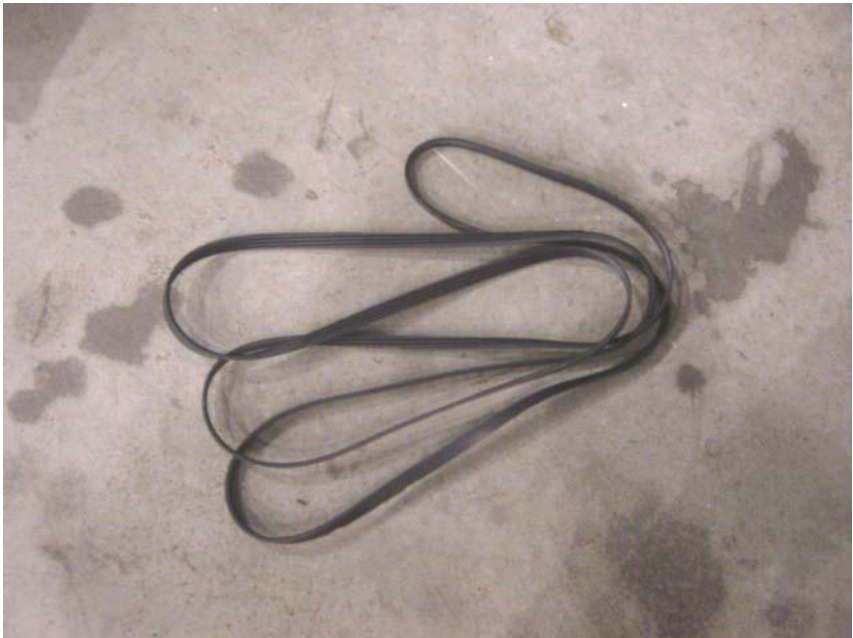
**TORN ENGINE ACCESSORY BELT
(2,645 TEST MILES)**

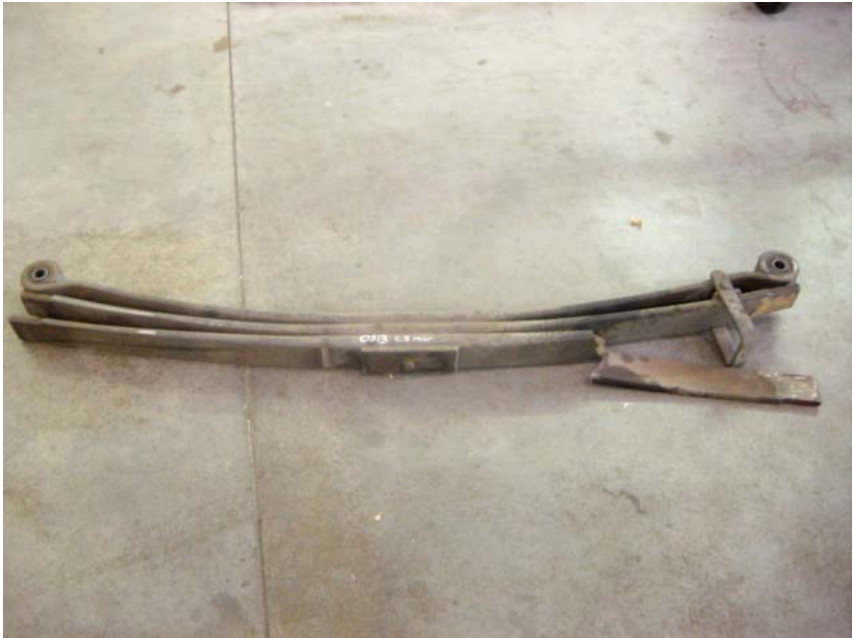
**BROKEN RIGHT REAR LEAF SPRING
(3,752 TEST MILES)**

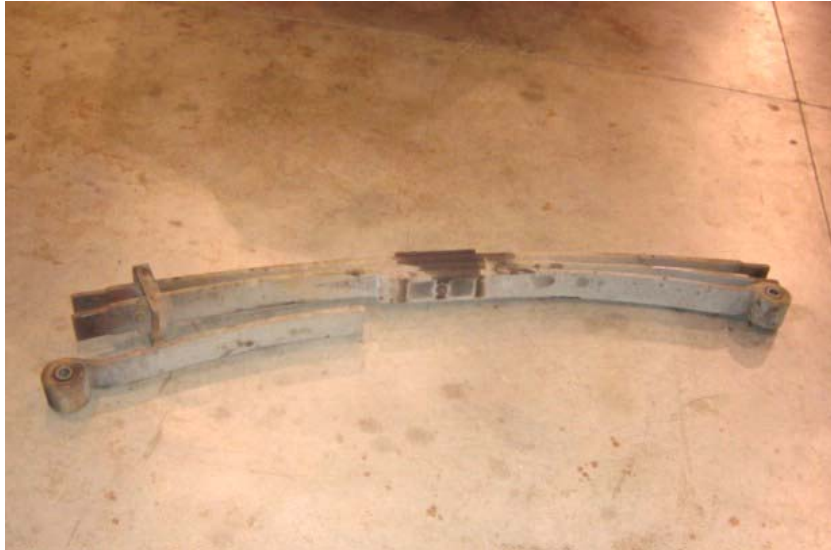
**BROKEN TOP LEAF ON THE LEFT
REAR SPRING BEAM
(3,795 TEST MILES)**

DATE	TEST MILES	SERVICE	ACTIVITY	DOWN TIME	HOURS
10-03-05	3,795	The top leaf of the left rear spring beam is broken.	Replaced spring beam.	8.00	3.00
10-11-05	4,904	The right front tire is flat.	Plugged right front tire.	0.50	0.50
10-11-05	4,904	One emergency window latch left side and on right side are broken	Replaced both latches.	0.50	0.50
10-11-05	4,904	Left side brake lights are burned out.	Replaced left side brake lamps.	0.25	0.25
10-14-05	5,581	The second and third leaves are broken on the right rear spring.	Replaced spring beam.	5.00	2.50
10-17-05	5,676	The second leaf is broken on the left rear spring beam.	Replaced spring beam.	6.00	2.50
10-20-05	6,019	The brake booster pump will not shut down.	Replaced failed relay.	8.00	0.50
11-04-05	8,706	Accessory belt is broken.	Replaced accessory belt.	2.00	0.50
11-09-05	9,535	The flange is broken on the exhaust drop pipe.	Welded/repairs flange.	2.00	1.00

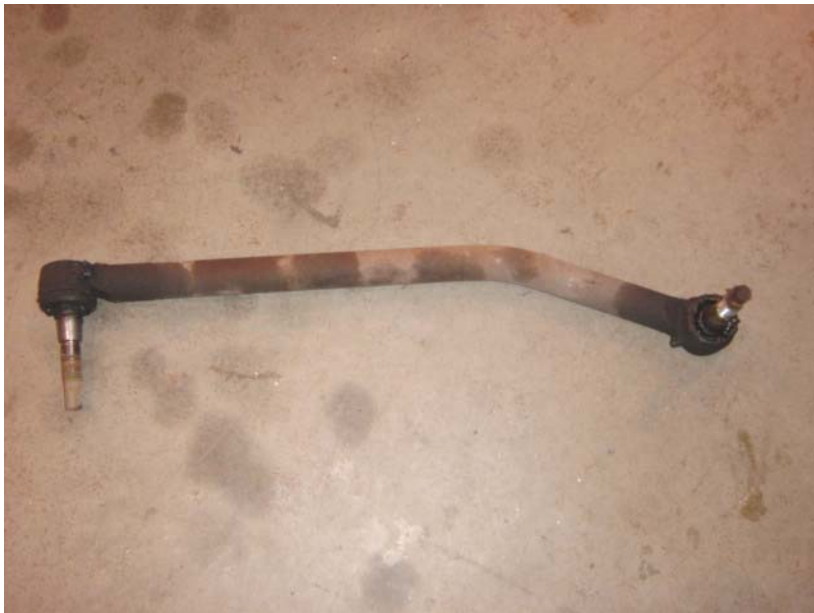
**WORN STEERING LINK
(9,774 TEST MILES)**

11-09-05	9,535	The body seam in the driver's area has nine missing fasteners.	Replaced nine missing fasteners in body seam at driver's area.	1.00	1.00
11-10-05	9,774	The steering link ends are worn.	Steering link replaced.	2.00	2.00
11-14-05	10,280	The under-seat heater is leaking coolant.	Removed and bypassed the heater.	2.00	0.50
11-17-05	11,250	The right rear inside tire is flat.	Replaced right rear inside tire.	4.00	1.00

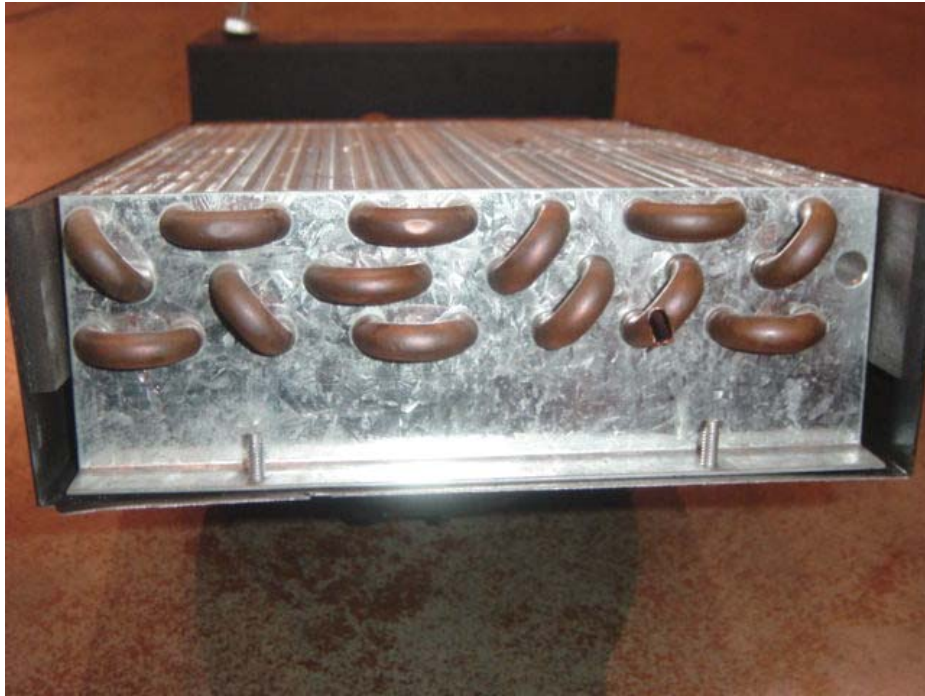
**LEAKING UNDER-SEAT HEATING UNIT
(10,280 TEST MILES)**
