**PARTIAL  
STURAA TEST  
7 YEAR  
200,000 MILE BUS  
from  
SUPREME CORPORATION  
MODEL TROLLEY TR 31**

**MARCH 2003**

**PTI-BT-R0302-P**

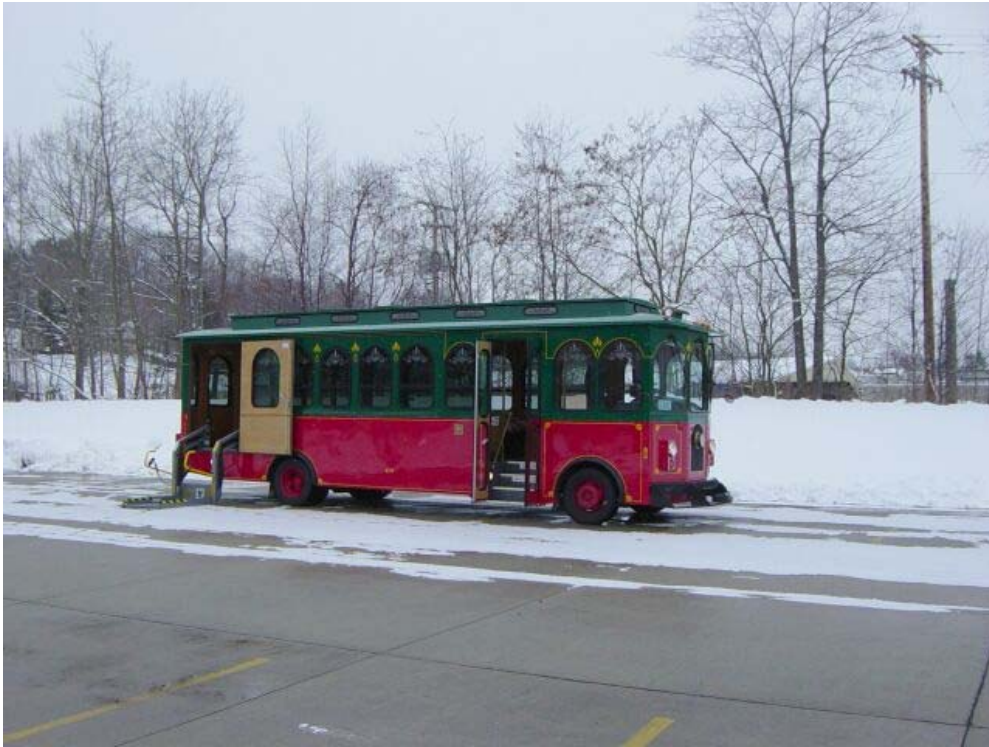
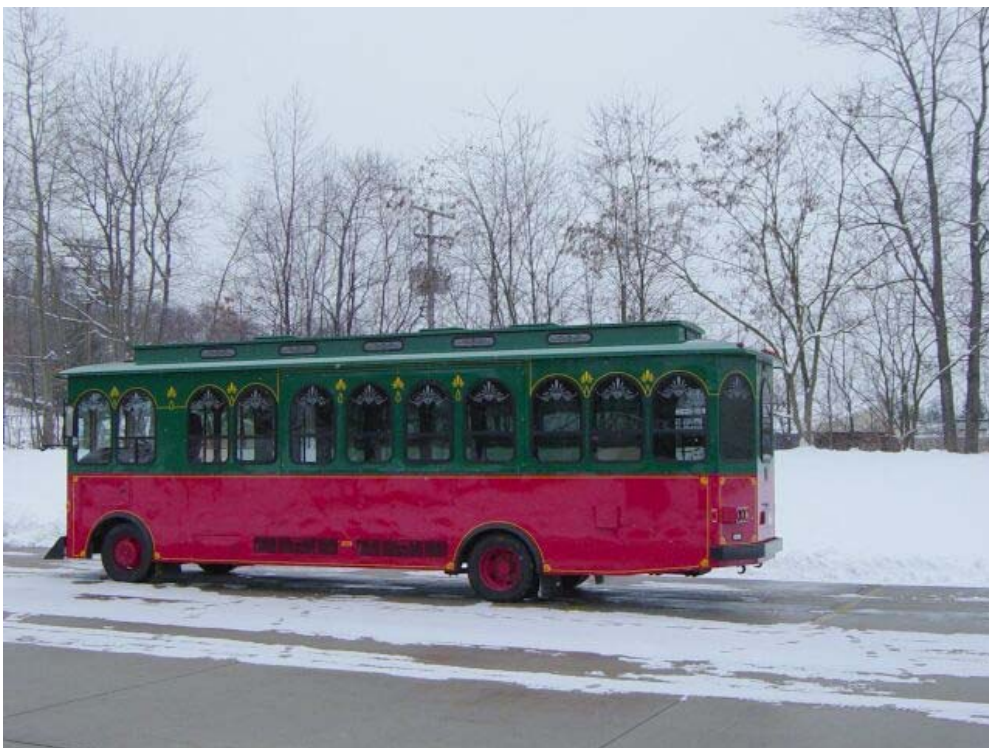
## SUPREME CORPORATION MODEL TROLLEY TR 31

The test bus consists of a Supreme Corporation, model Trolley TR 31. The trolley is built on a Ford F-53 chassis. The trolley has a front door, rear of the front axle, and a rear door equipped with a Maxon model WL-6A handicap lift, located rear of the rear axle. Power is provided by a gasoline-fueled, Ford Motor Co., model 6.8L engine coupled to a Ford Motor Co. model E40D transmission.

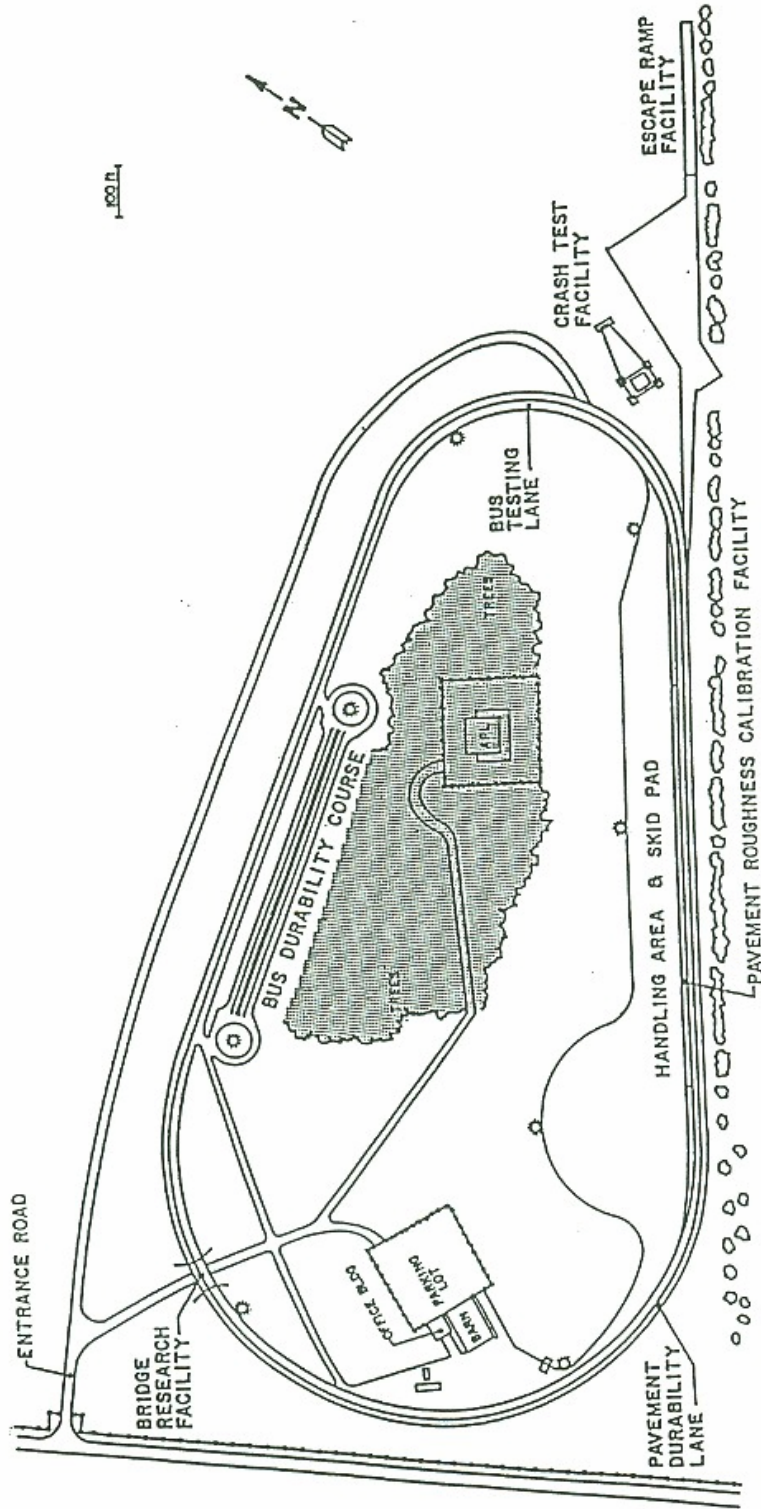
# “PLAN VIEW OF PENN STATE BUS TESTING AND RESEARCH FACILITY”

The following mileage summary presents the accumulation of miles during the Structural Durability Test. The driving schedule is included, showing the operating duty cycle. A detailed plan view of the Test Track Facility and Durability Test Track are attached for reference also, a durability element profile detail shows all the measurement of the different conditions. Finally, photographs illustrating some of the failures that were encountered during the Structural Durability Test are included.
