**PARTIAL**  
**STURAA TEST**  
**7 YEAR**  
**200,000 MILE BUS**  
**from**  
**CABLE CAR CONCEPTS**  
**MODEL 208" WB MAXI DIESEL FUELED TROLLEY**

**MAY 2003**  
**PTI-BT-R0306-P**

**The Pennsylvania Transportation Institute**

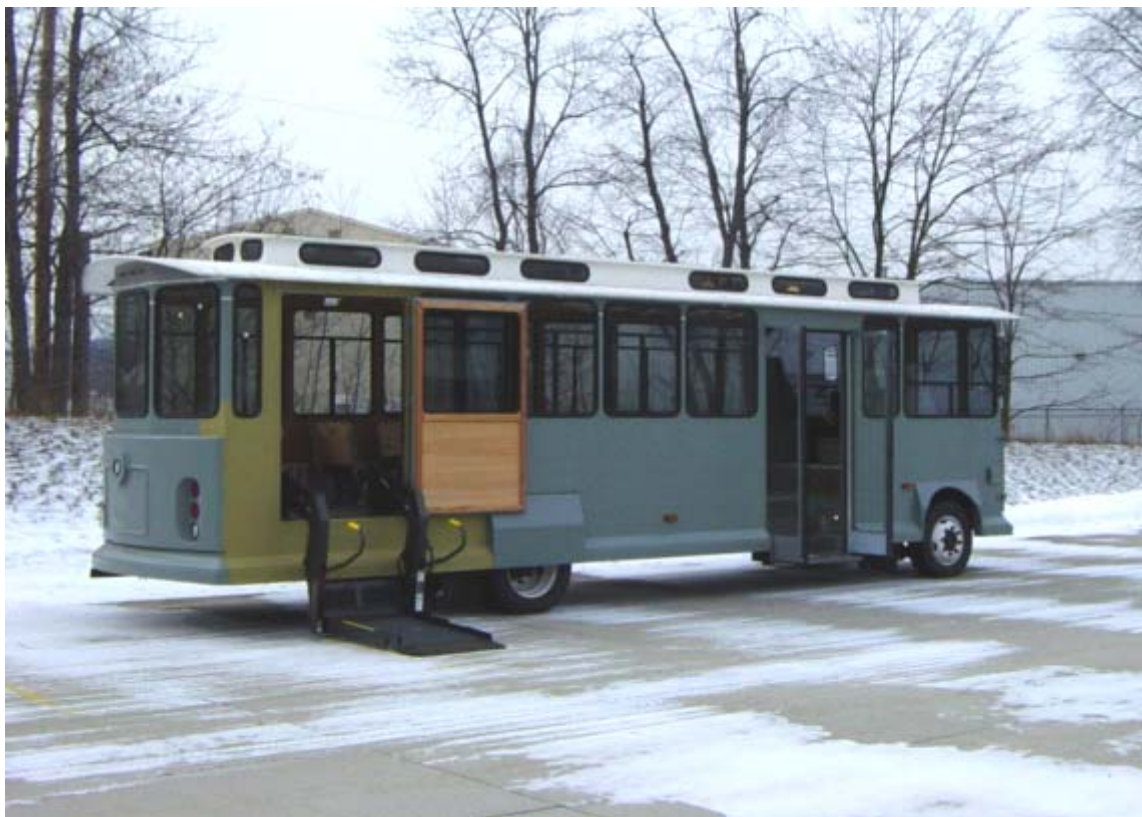
**CABLE CAR CONCEPT'S  
MODEL 208" WB MAXI DIESEL FUELED TROLLEY  
EQUIPPED WITH A BRAUN CORPORATION,  
MODEL L915FIB PLATFORM LIFT**

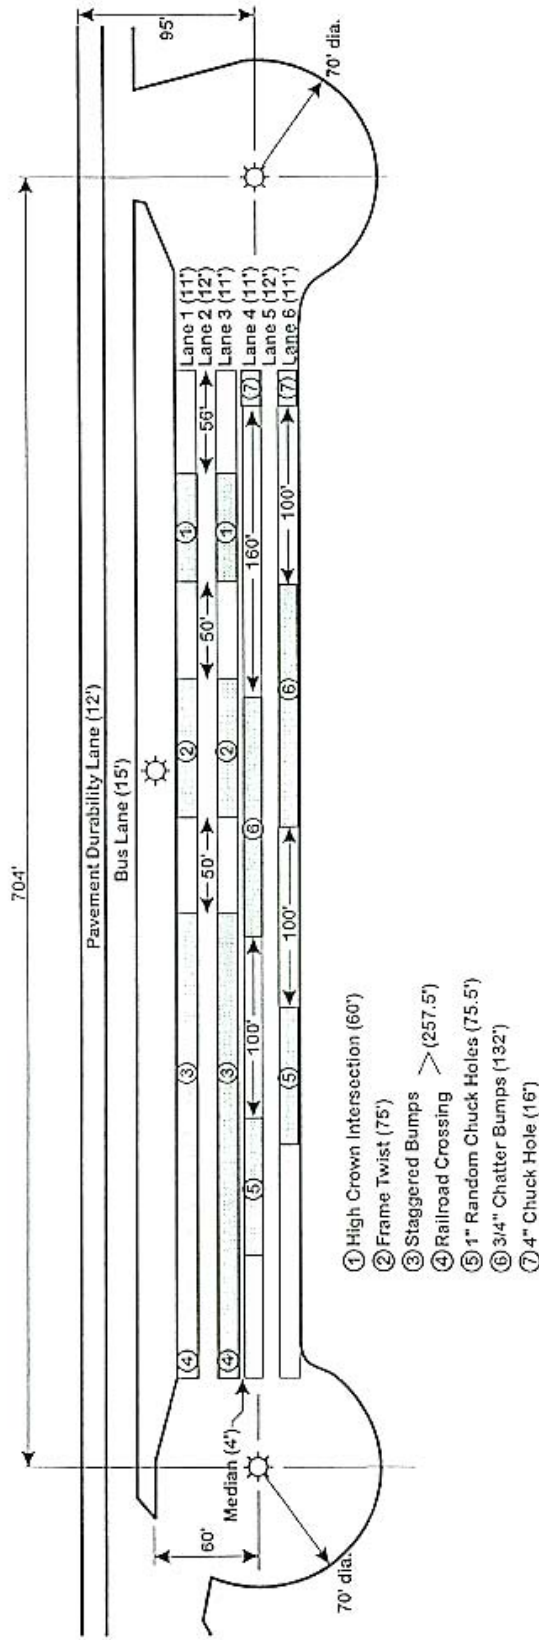
Plan View

# Vehicle Durability Test Track

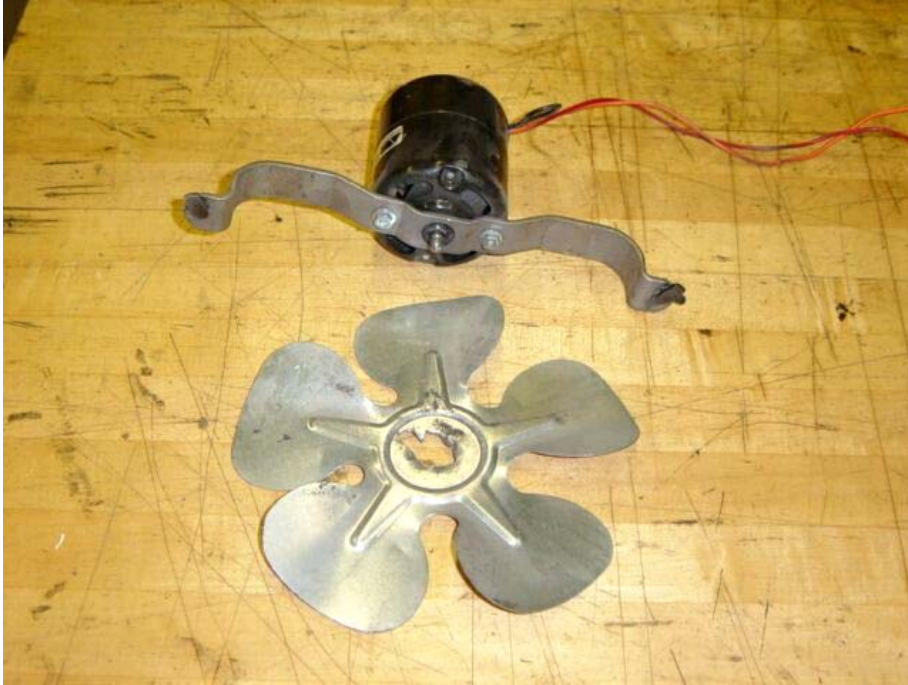
**REAR BLOWER MOTOR AND FAN  
(1,635 TEST MILES)**

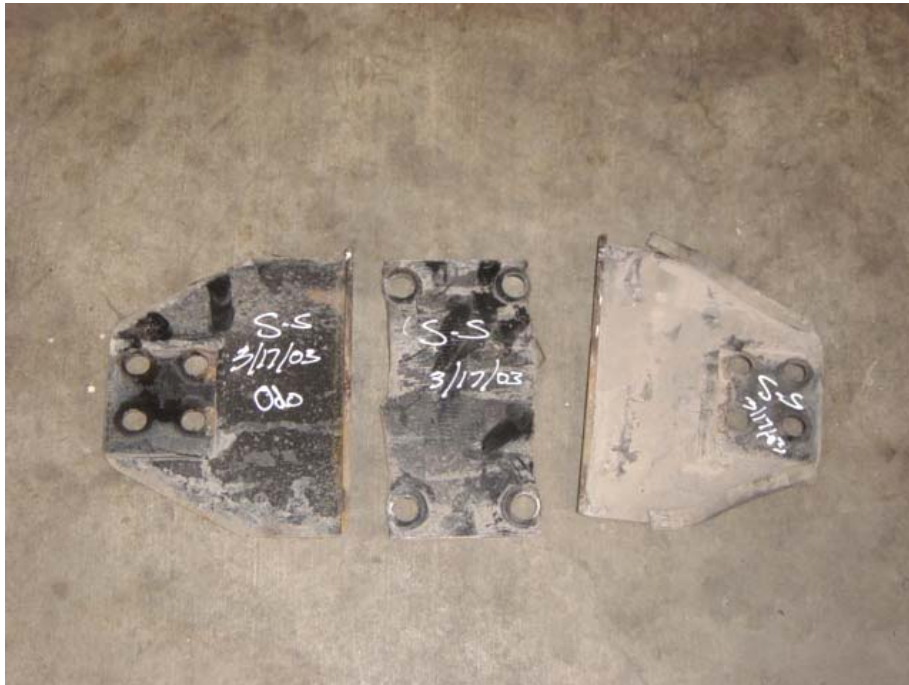
**BROKEN REAR SPRING HANGER  
CROSS MEMBER END BRACKETS  
(4,267 TEST MILES)**

<b>DATE</b>	<b>TEST MILES</b>	<b>SERVICE</b>	<b>ACTIVITY</b>	<b>DOWN TIME</b>	<b>HOURS</b>
02-12-03	260	The dash lights are inoperative.	5 amp fuse is missing from the fuse panel—5 amp fuse installed.	0.50	0.50
02-12-03	260	Inspect for a noise in the front suspension.	Loose front sway bar link bracket bolts torqued.	0.50	0.50
02-13-03	529	The front sway bar link bracket bolts are loose.	Torqued bolts on the front sway bar link bracket.	1.00	1.00
02-14-03	688	The front sway bar link bracket bolts are loose.	Nylok nuts installed on front sway bar link bracket bolts.	0.50	0.50
02-21-03	1,635	No heat in the rear of the bus.	The fan motor in the rear floor heater came loose and broke the fan blades. Broken fan blades removed. Parts ordered.	0.50	0.50
02-27-03	1,780	New fan blades that were ordered on 02/21/03 arrived.	Installed new fan blades in rear floor heater.	0.50	0.50
03-17-03	4,267	The end brackets on the cross member located between the rear spring hangers are broken.	Both end brackets replaced.	1.50	1.50

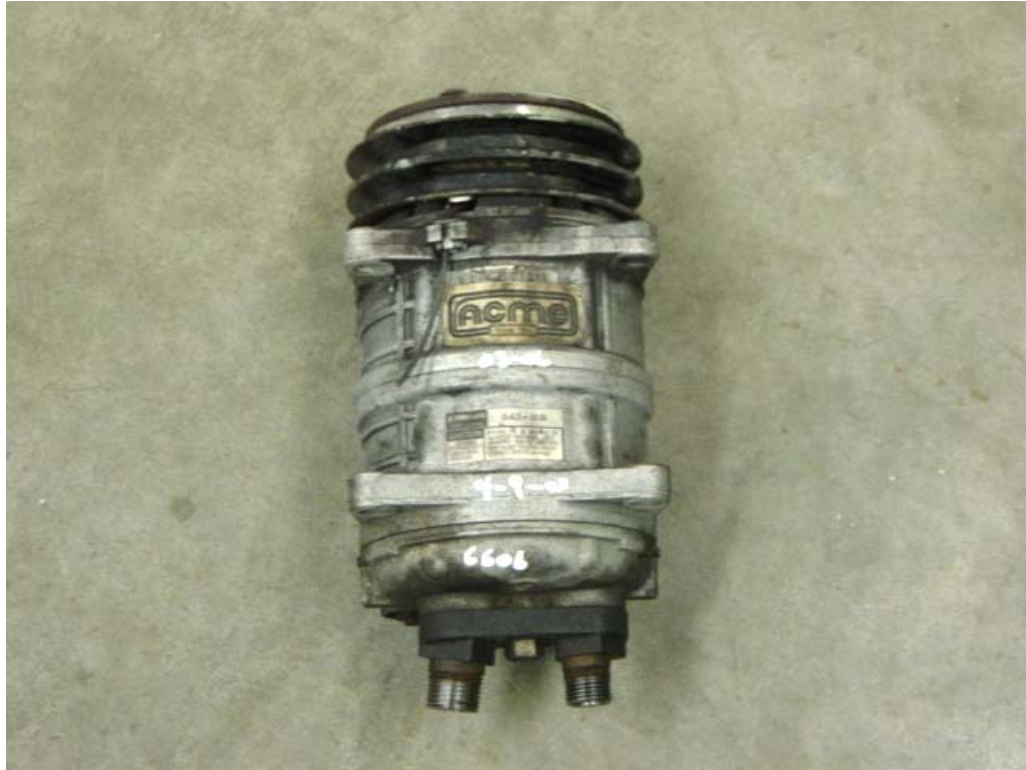
**FAILED A/C COMPRESSOR CLUTCH  
(6,217 TEST MILES)**

<b>DATE</b>	<b>TEST MILES</b>	<b>SERVICE</b>	<b>ACTIVITY</b>	<b>DOWN TIME</b>	<b>HOURS</b>
03-20-03	4,786	The rear heater blower motor has broken loose damaging the fan blades.	Rear heater blower motor and fan removed.	1.00	1.00
03-20-03	4,786	The left door panel, lower pivot pin is missing.	Lower pivot pin replaced.	2.00	2.00
04-02-03	5,927	The roof frame around the A/C unit has cracked.	Welded and repaired cracks in roof frame.	8.00	8.00
04-03-03	6,027	Test driver noticed smoke coming from the engine compartment. The upper A/C compressor clutch has seized.	Power to both compressors disconnected. Notified warranty dealer.	0.50	0.50
04-04-03	6,101	Both front lower sway bar bushings are worn.	Both front lower sway bar bushings replaced.	2.00	2.00
04-09-03	6,217	The upper A/C compressor clutch has seized (reported on 04/04/03).	Warranty dealer (Thermo King) replaced compressor.	4.50	4.50
